RECONDITIONING A BUSCH COBRA AC0800 DRY SCREW

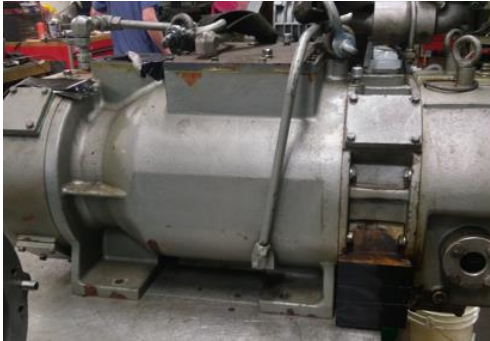
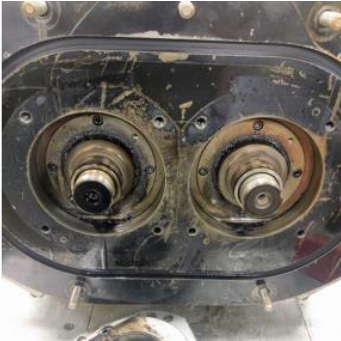
BEFORE

- Base repair quote supplied to customer prior to receiving the equipment
- Complete visual inspection and disassembly of dry screw and components
 - Seals failed

- Minor contact on drive slinger seal to retainer plate
- Pictures of tear down taken and included in firm quote with detailed description of required repairs
