RECONDITIONING A TUTHILL 5400 (9027) VACUUM BOOSTER

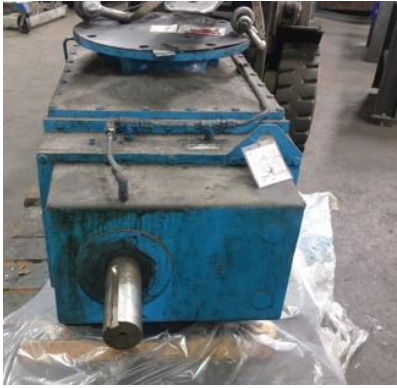
BEFORE

- Base repair quote supplied to customer prior to receiving the equipment
- Complete visual inspection and disassembly of booster and components
 - Process material build up in booster

- Bearing failure on drive end, driven rotor
- Pictures of tear down taken and included in firm quote with detailed description of required repairs
- Firm quote submitted to customer for approval prior to continuance of work

- Complete mechanical and chemical cleaning of all internal components and external surfaces
 - Chrome and grind bearing race on non-drive end
 - Clean up rotor ends

- Ceramic coat seal sleeves
 - Balance rotors
 - Clean heat exchanger and replace gaskets
 - Installation of new seals, bearings, gaskets and O-rings
 - Replace seal sleeve

- Replace oil sight glasses
 - Replace non-drive end endplate
 - Replace gear assembly
 - Replace oil filter
- Set internal clearances to factory specs
- 60-minute test run of complete assembly with data acquisition program

- After break-in period has been met, system is helium leak-checked
- Copy of test data acquisition pump down curve included in shipping documents
- Prep, paint and palletize for shipment
