RECONDITIONING A TUTHILL KT850D ROTARY PISTON PUMP

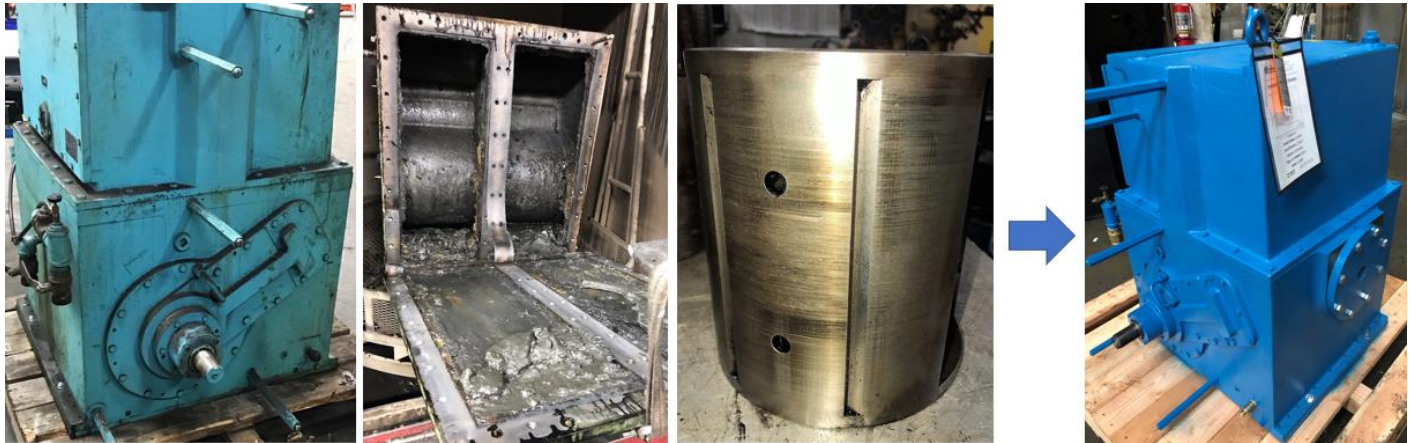
BEFORE

AFTER

- Oil contaminated / Dirty
- Pictures of tear down taken and included in firm quote with detailed description of required repairs
- Firm quote submitted to customer for approval prior to continuance of work

- Base repair quote supplied to customer prior to receiving the equipment
- Complete visual inspection and disassembly of rotary piston pump and components

- Complete mechanical and chemical cleaning of all internal components and external surfaces
 - Clean water jacket – replace water jacket gaskets
 - Ceramic coat two each Babbitt sear areas of shaft

- Installation of all new seals, bearings, gaskets, O-rings and vanes
 - Replace center slide pin and outer slide pins
 - Install new style valve plates
 - Replace oil pump, oil pump insert, oil pump inlet elbow and fittings

- Replace temperature and oil pressure gauges
 - Replace check valve
- Set internal clearances to factory specs
- 60-minute test run of complete assembly with data acquisition program

- After break-in period has been met, system is helium leak-checked
- Copy of test data acquisition pump down curve included in shipping documents
- Prep, paint and palletize for shipment
