## RECONDITIONING AN EDWARDS EH1200 VACUUM BOOSTER

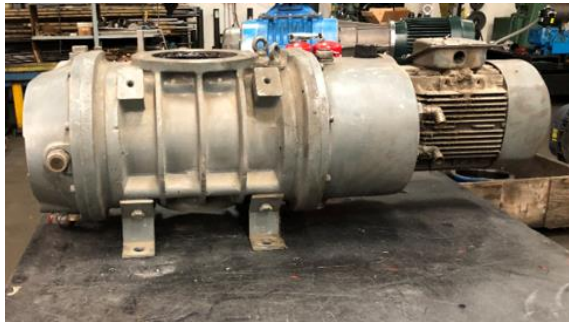
BEFORE

- Base repair quote supplied to customer prior to receiving the equipment
- Complete visual inspection and disassembly of booster and components
  - Unit locked up

- Minor contact noted on non-drive end
  - Bearing bores out of spec on non-drive end
- Pictures of tear down taken and included in firm quote with detailed description of required repairs

- Firm quote submitted to customer for approval prior to continuance of work
- Complete mechanical and chemical cleaning of all internal components and external surfaces

- Ceramic coat seal journals
  - Installation of new seals, bearings, gaskets and O-rings
  - Replace sight glasses
  - Replace shaft sleeves
  - Replace two non-drive end bearing housings

- Replace coupling enclosure
  - Replace motor bearings
- Set internal clearances to factory specs
- 60-minute test run of complete assembly with data acquisition program

- After break-in period has been met, system is helium leak-checked
- Copy of test data acquisition pump down curve included in shipping documents
- Prep, paint and palletize for shipment
